Case Study

Bottled Water Company Implements Large Format
Polymer Windows

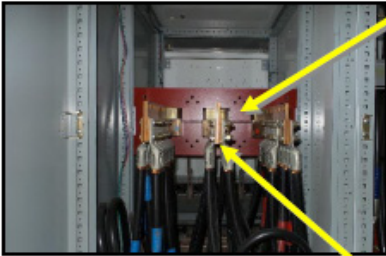
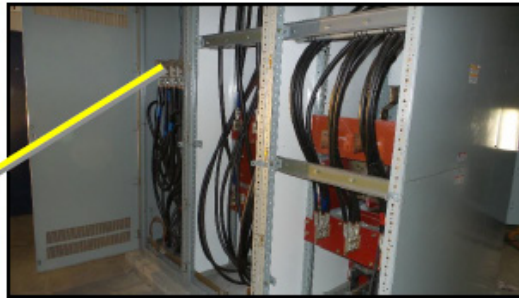
Main Breaker Buss - Cabinet A

Main Breaker Buss	CAP-CT-24
Main Breaker Load	CAP-CT-24
Fused Breakers	CAP-CT-24

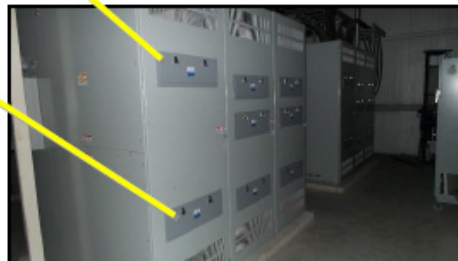
Cabinet A, B, C

SWGR 96-SWG-01

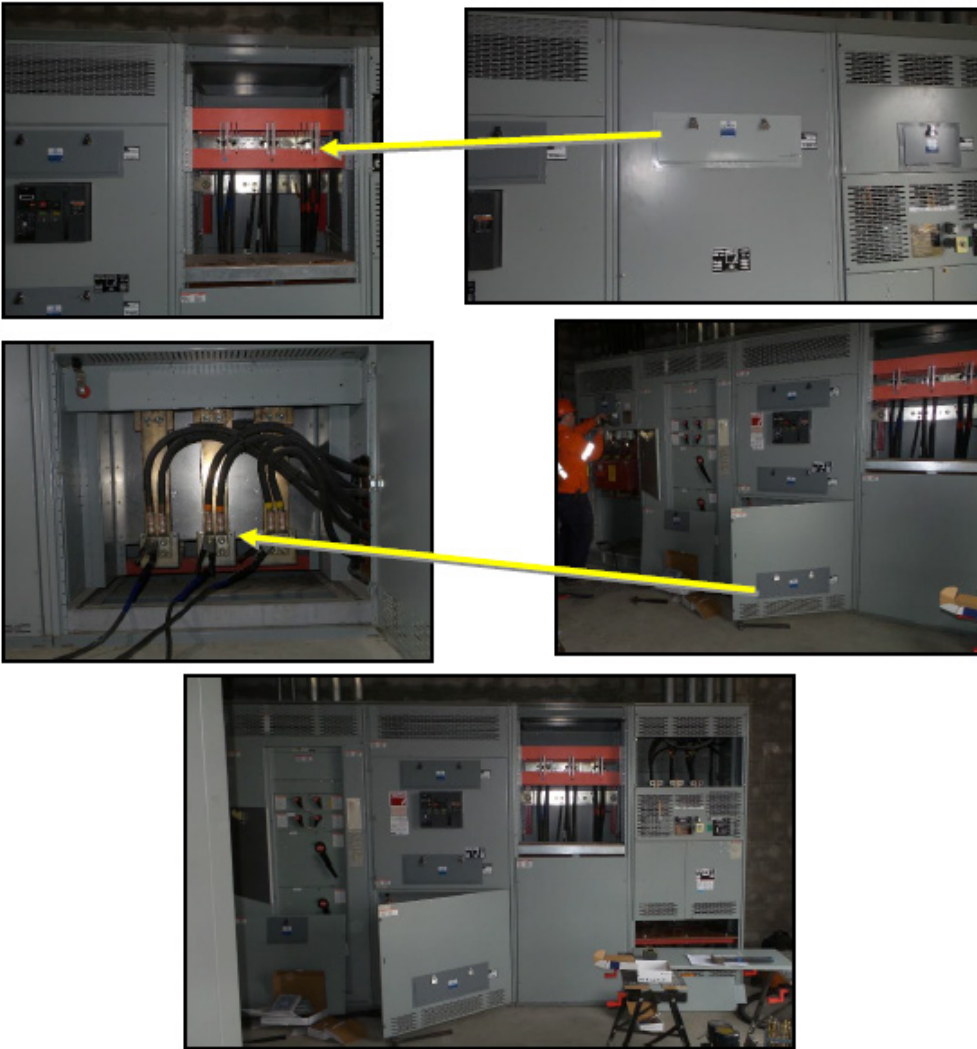
Installation Requirements:
Incoming line connections CAP-CT-24
Main Breaker CAP-CT-24
