Preventing Crisis On The High Seas by Adding Infrared Windows Inspection Capability

By: Karen Fox, CRL, Level 2 Electrical Thermographer, Level 1 Airborne Ultrasound, IRISS, Inc.

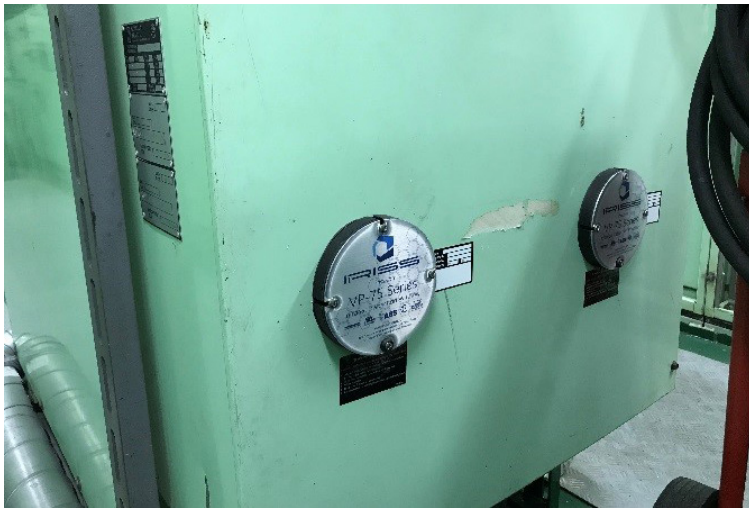
The above photo shows a dry step-down transformer with the VPT-75 installed.

The reliability of the main systems and the subsystems as well as critical electrical equipment was identified and the IRISS VPT-75 three inch diameter round windows were installed into dry transformer panel covers in the engine room.

In this case, the step-down transformer equipment was identified, and the correct size and placement of the Infrared Window was determined. When the ship was brought into scheduled dry-dock, the equipment was completely de-energized to make sure it was safely isolated, locked out and tagged out. Once de-energized, the electricians removed the covers and the Infrared Windows were retrofitted. Approval to re-energize and operate the equipment was obtained and locks and tags were removed. The electricians confirmed the equipment was operating at normal load levels and allowed sufficient time for the equipment to become thermally stable. Infrared thermography was then performed on the equipment and any issues were noted. Inspections are now scheduled on a semi-annual basis and spot checks are performed whenever there is any suspicion of a problem due to other warning signs being picked up by the maintenance and operations staff.
