Insulation of commercial walk in freezers checked with thermal imaging

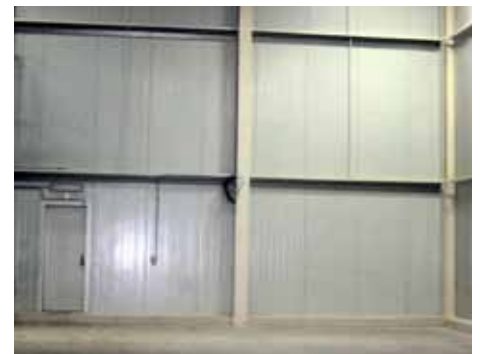
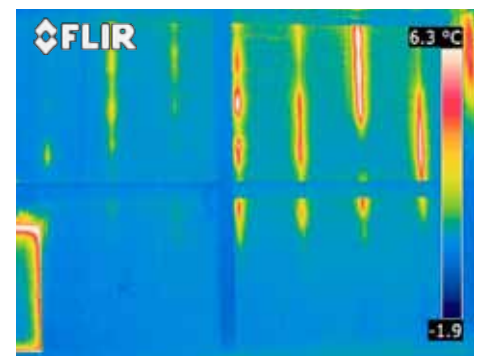
Improper welding has caused heat leakage in this section of the freezer insulation, as shown in this thermal image

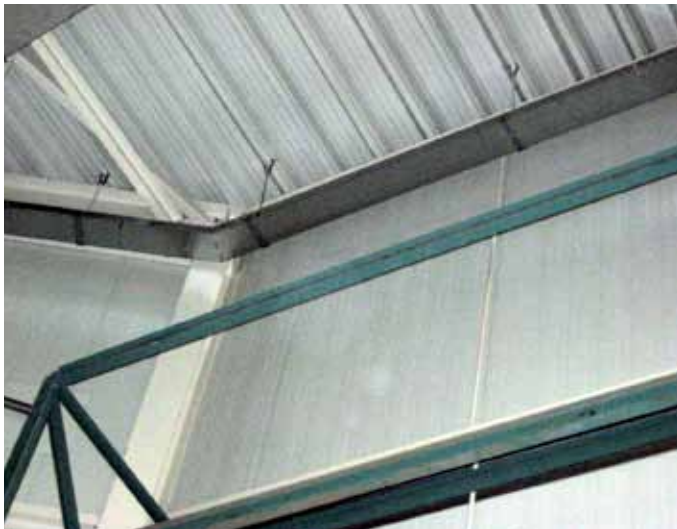
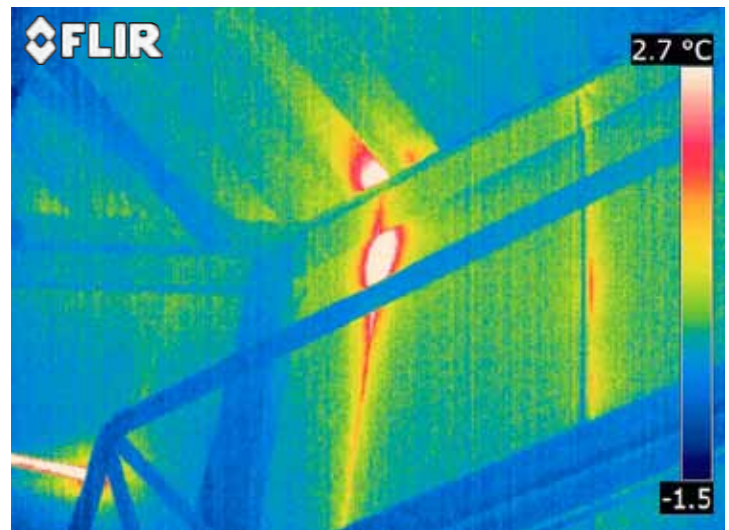
This thermal image shows an example of improperly connected joints between insulation panels, causing heat leakage.

newly built refrigeration units have a faulty construction. Sometimes the joints between the insulation panels are not protected properly, creating heat bridges. This can cause a lot of unnecessary energy consumption. In other cases older units might develop insulation faults over time due to wear. In both scenarios the best way to detect these insulation defects is by using thermal imaging cameras. Other methods, like spot pyrometers and such, really are not an option with this type of inspection. It is simply too easy to miss problems that you can relatively easily detect using thermal imaging."

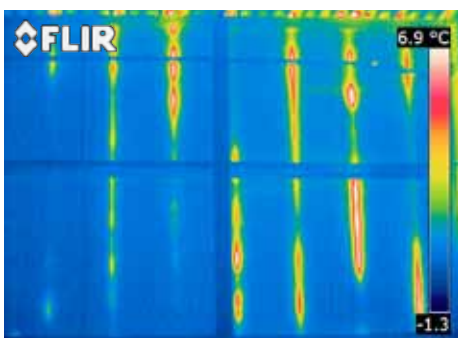
This thermal image shows heat leakage due to improperly connected joints between insulation panels, causing a lot of unnecessary energy consumption.
