APPLICATION STORY

COMPACT THERMAL IMAGING CAMERA FROM FLIR CONTINUOUSLY MONITORS PACKAGING QUALITY

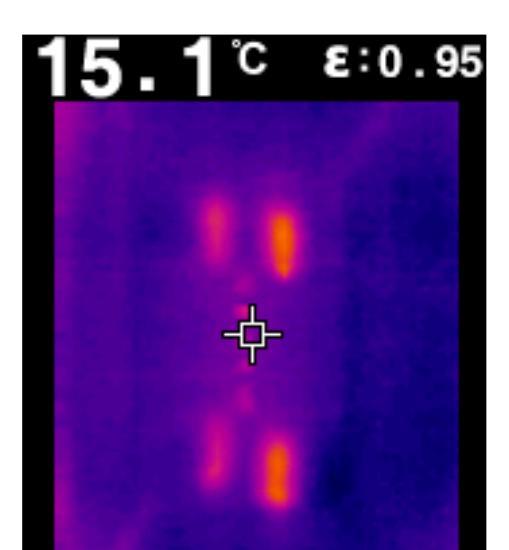
In their search of an efficient glue monitoring solution, Recochem decided to try a single-spot IR sensor. "Because the glue is heated, we can use temperature information to inspect the glue spots," says Adam Wolszczan. "However, we did not Combining thermal and visual cameras in a small, affordable package, the AX8 provides continuous temperature monitoring and alarming capabilities.

FLIR AX8 is a thermal sensor with imaging capabilities. Combining thermal and visual cameras in a small, affordable package, the AX8 provides continuous temperature monitoring and alarming for of critical electrical and mechanical equipment.

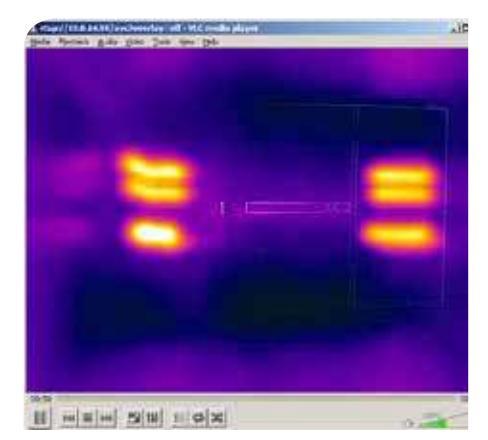
The FLIR TG165 proved to Recochem that thermal imaging cameras can see through cardboard and check the pattern and size of the applied glue spots. This meant that it was no longer necessary to destroy the boxes for inspection.

Adam Wolszczan used the TG165 to have a look at some of the boxes that come off the production line and the camera clearly showed him where the hot glue spots were located. What's more, the FLIR TG165 thermal imaging camera was able to "see" through the cardboard and check the pattern and size of the applied hot melt adhesive. This meant that it was no longer necessary to destroy the boxes for inspection. It convinced Adam Wolszczan that thermal imaging technology was the path to be followed: "We contacted FLIR Systems and found a suitable solution with the FLIR AX8 thermal The AX8 is very imaging sensor. affordable and very compact: just what we needed for our application."

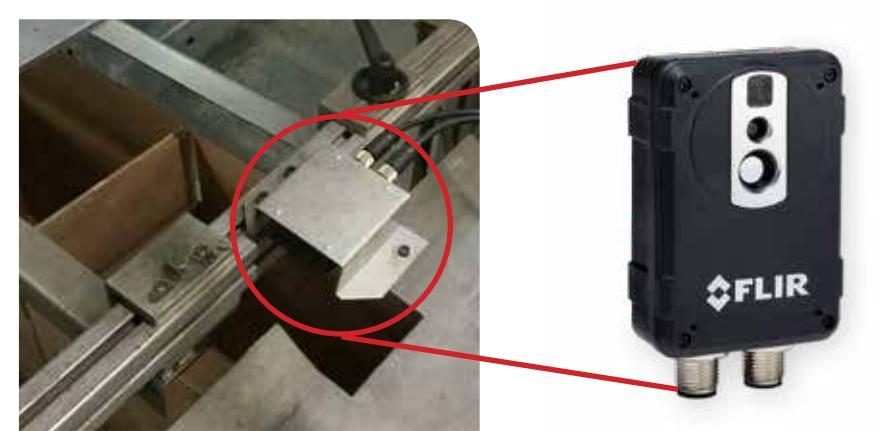
The AX8 camera is set up to look at predefined areas of the flaps where glue should be applied, and verify spot sizes and their temperatures.

If you look at the AX8 thermal images, then you clearly see the hotter spots where the glue has been applied. Whenever a glue gun is delayed, you see a position shift of the hot spots, so you instantly know when something is wrong.

The AX8 camera is now set up to look at predefined areas of the flaps where glue should be applied, and verify spot sizes and their temperatures. Thanks to its compact size, the AX8 thermal imaging sensor can be installed in such a way that it can look at the bottom of the box. And since the AX8 can see the heat through the carton, it is no longer needed to destroy any more boxes for inspection. The acquired video images can be viewed by an operator on a dedicated screen.

"If you look at the AX8 thermal images, then you clearly see the hotter spots where the glue has been applied. Whenever a glue gun is delayed, you see a position shift of the hot spots, so you instantly know when something is wrong. It's very straightforward and very effective."
