## 100% quality control of resistors with FLIR thermal imaging camera

### Reducing failure rates by 100% control

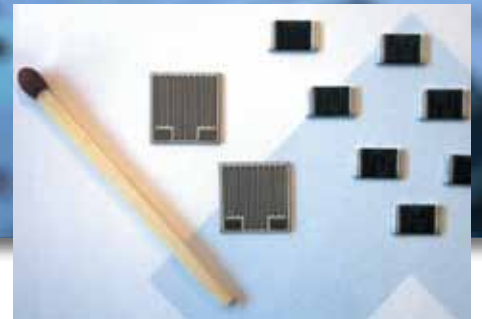
100% perfect resistors produced by Isabellenhütte-Heusler.

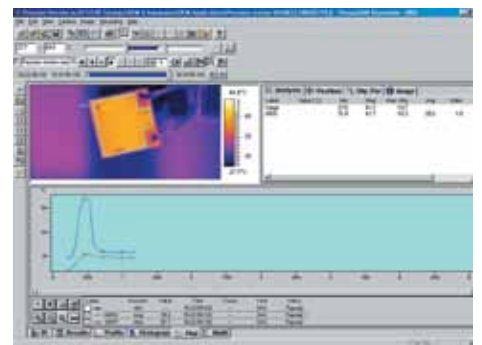
The FLIR Systems thermal imaging camera detects even the smallest defect in a resistor.

The solution that Isabellenhütte adopted was to install a thermal imaging camera system from FLIR Systems. This is used to inspect each component produced. Within a timeframe of less than 1 second, the system makes an infrared image that allows it to check the resistor for possible defects. These are shown as hot spots in the image, resulting from the higher surface temperature of a faulty device.

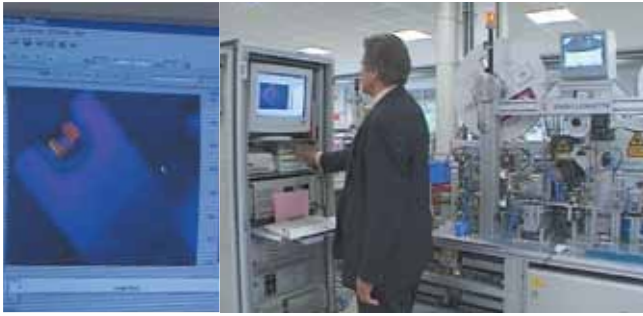
Fully automated quality control thanks to the FLIR Systems thermal imaging camera.

this means that the component has a hot spot. When a hot spot is detected a trigger signal is automatically generated to remove the faulty component from the production line. The whole process takes less than 1 second, from the entry to the exit of the testing machine. The thermal image with the defective area on the component is stored in a database for statistical process control purposes.

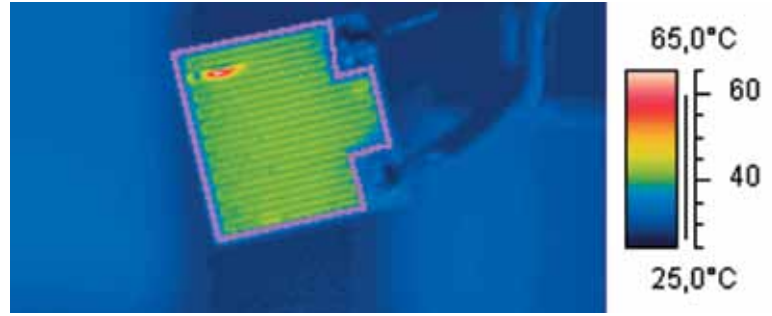
A flawed resistor controlled with a thermal imaging camera

time. Within 20 ms the thermal imaging camera observes the thermal cycle of the component. Using the machine vision software IRCheck designed by the system integrator Automation Technology ([www.automationtechnology.de](http://www.automationtechnology.de)), the computer compares the maximum detected temperature with the average surface temperature of the resistor. If the difference between the maximum and average values exceeds a predefined value,

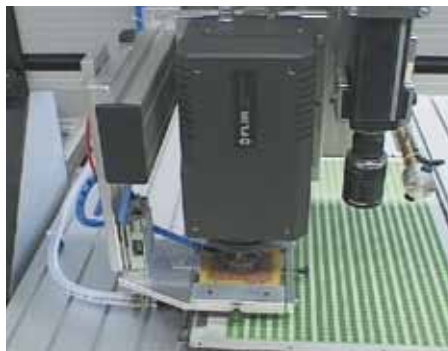
Each component is individually inspected by the FLIR thermal imaging camera.

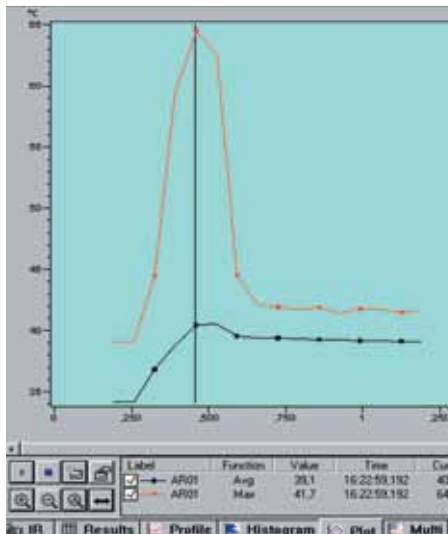
The time trend analysis of the maximum and average temperatures of a faulty component, using the specially developed machine vision software.

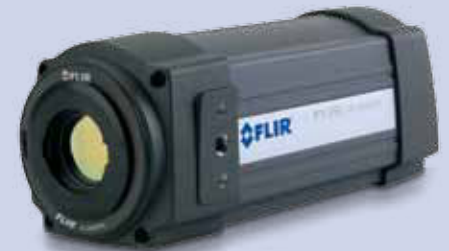
### FLIR A310

The thermal imaging camera used for this application is the ThermoVision™ A320M. This model has been replaced by the even better performing FLIR A310

The FLIR A310 is a compact fixed mounted camera that can be installed almost anywhere. It can measure temperature differences as small as 0.05 °C. Exclusive measurement analysis function and alarm functions make the FLIR A310 the perfect tool for many applications.
